Substandard Roofing Battens

November 2022

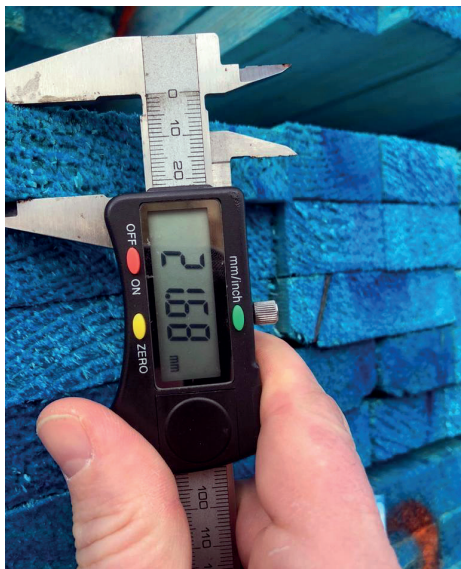
1. Check the thickness of the batten, as BS 5534 states that a batten should be 25 mm thick with a tolerance of -0/+3 mm. Therefore a roofing batten less than 25 mm thick (see picture on the left) should not be purchased or used.

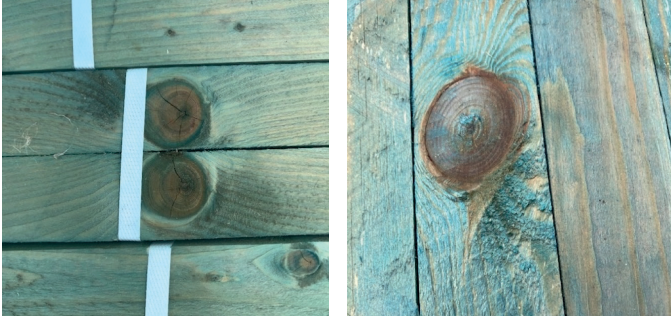
2. Check to see if any knots are present. BS 5534 states that *'the sum of both faces can be no more than the width, i.e. 38 mm/50 mm'*. Therefore, if a knot is visible on both sides of a batten, when added together the overall size should not be more than 38 mm or 50 mm. Below shows images of battens with excessive knots, that **should not be used**.

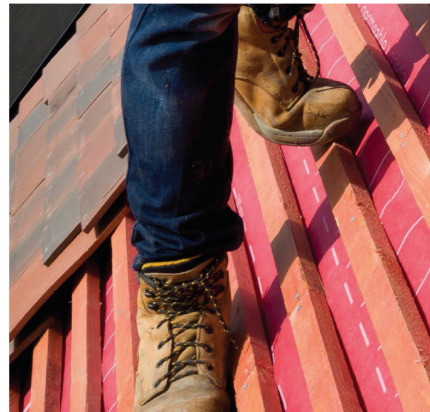
When using battens as footholds, the weight of the roofer must always be on or as close as possible to the rafter/batten junction where the fixings are. The roofer's foot should be above the rafter wherever possible, rather than on the batten and under no circumstance should the roofer deliberately walk mid-span on battens with open rafters.
