NFRCGuidance Note (GN57)

Encouraging Roof Nesting Birds

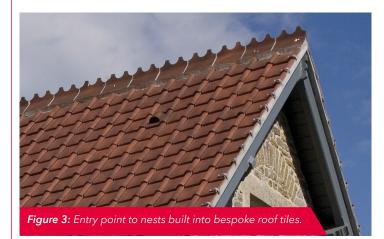
Correct placement of bird box products is fundamental to the successful uptake by nesting birds. Things to consider include:

- Making sure that the birds have a clear flight path to the nest.
- Avoiding placement close to windows and doors. A position near the eaves or the highest point of the gable of the property is preferable.
- Multiple boxes can be used for colonial nesting species such as the swift and house sparrow.
- Bird boxes often support a wider range of small bird species, not just the target species.

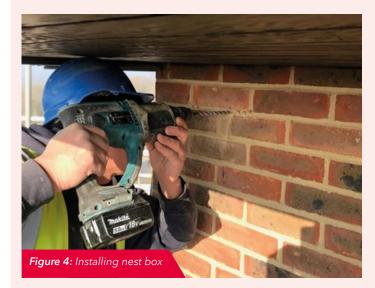
Clarke Roofing Southern Limited completed their work at the end of 2021 and during the course of the contract they were asked to fit S Brick swift boxes. S Bricks are a type of swift box supplied by Action for Swifts which are the size of a standard brick, just slightly deeper, so very convenient to integrate into both new-build and retrofit projects.

Operatives drilled out brickwork and fitted nest bricks, incorporating clear perspex screens to the rear. An internal platform was constructed within the tower in order to house cameras focusing on the birds' nesting and feeding habits through a breeding season. Once swifts were nesting in the clock tower bricks, live streamed video footage of occupied nests could then be shown in the library.
