**PCS01:**  
NFRC PROJECT CASE STUDY

# Reinforced Autoclaved Aerated Concrete (RAAC) Removal

BEDFORD MODERN SCHOOL (BMS), Manton Lane, Bedford, MK41 7NT

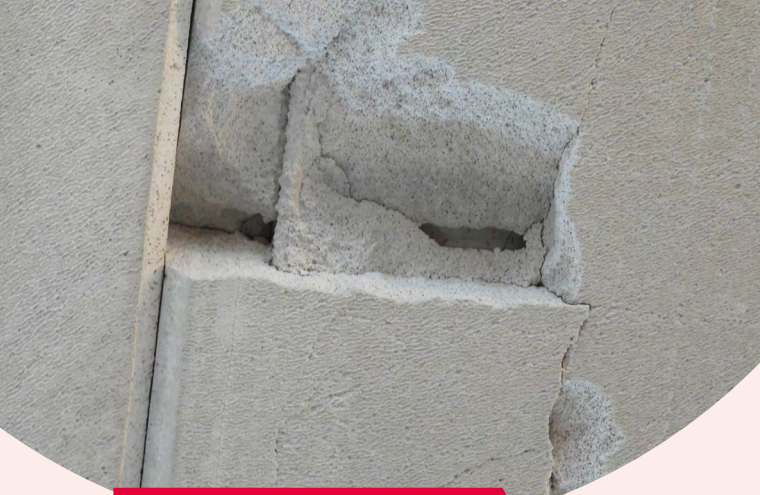
Figure 1: Crumbling RAAC plank

In *figure 1* you can see the extent of the failure to the RAAC, meaning the team at M&J Group had to work fast. In conjunction with Bedford Modern School, they introduced safety measures until the removal of RAAC planks to the affected roof areas could be managed safely.

Removal of existing Reinforced Autoclaved Aerated Concrete (RAAC) planks.

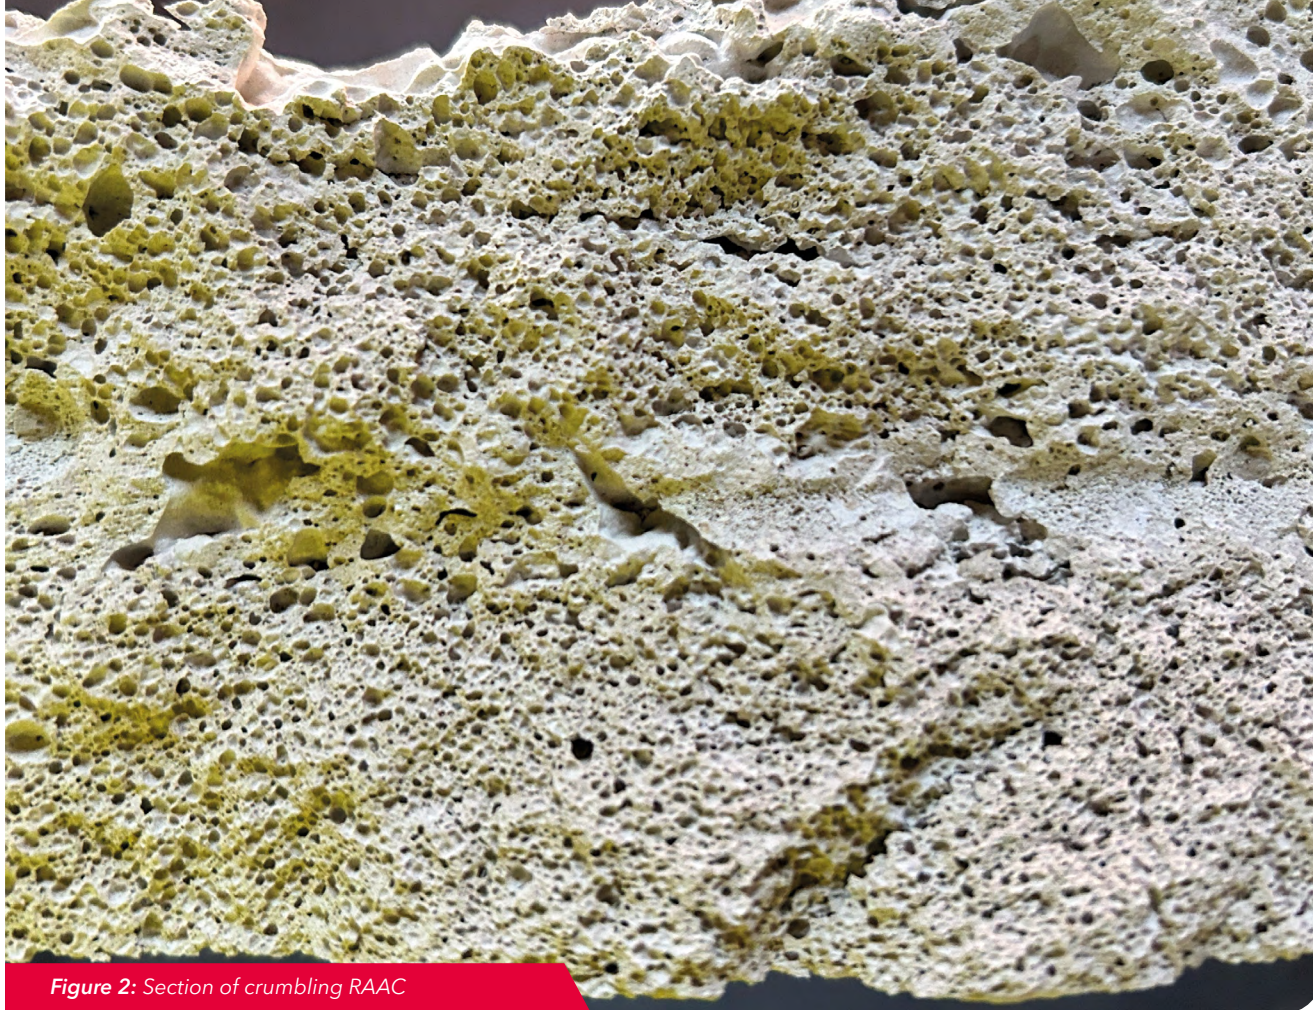
Figure 2: Section of crumbling RAAC

RAAC is a building material used in some buildings between the mid-1950s and mid-1990s to form roof planks, wall panels, and sometimes floor planks. RAAC is a highly-aerated, lightweight, concrete-based material (**highlighted in figure 2**) with different material properties to conventional concrete. Problems associated with older forms of the construction include high deflection, corrosion, spalling, and, where there is a low-end bearing, the possibility of sudden collapse due to cracking. Its presence has been confirmed in a range of public sector properties including schools and hospitals across the United Kingdom.

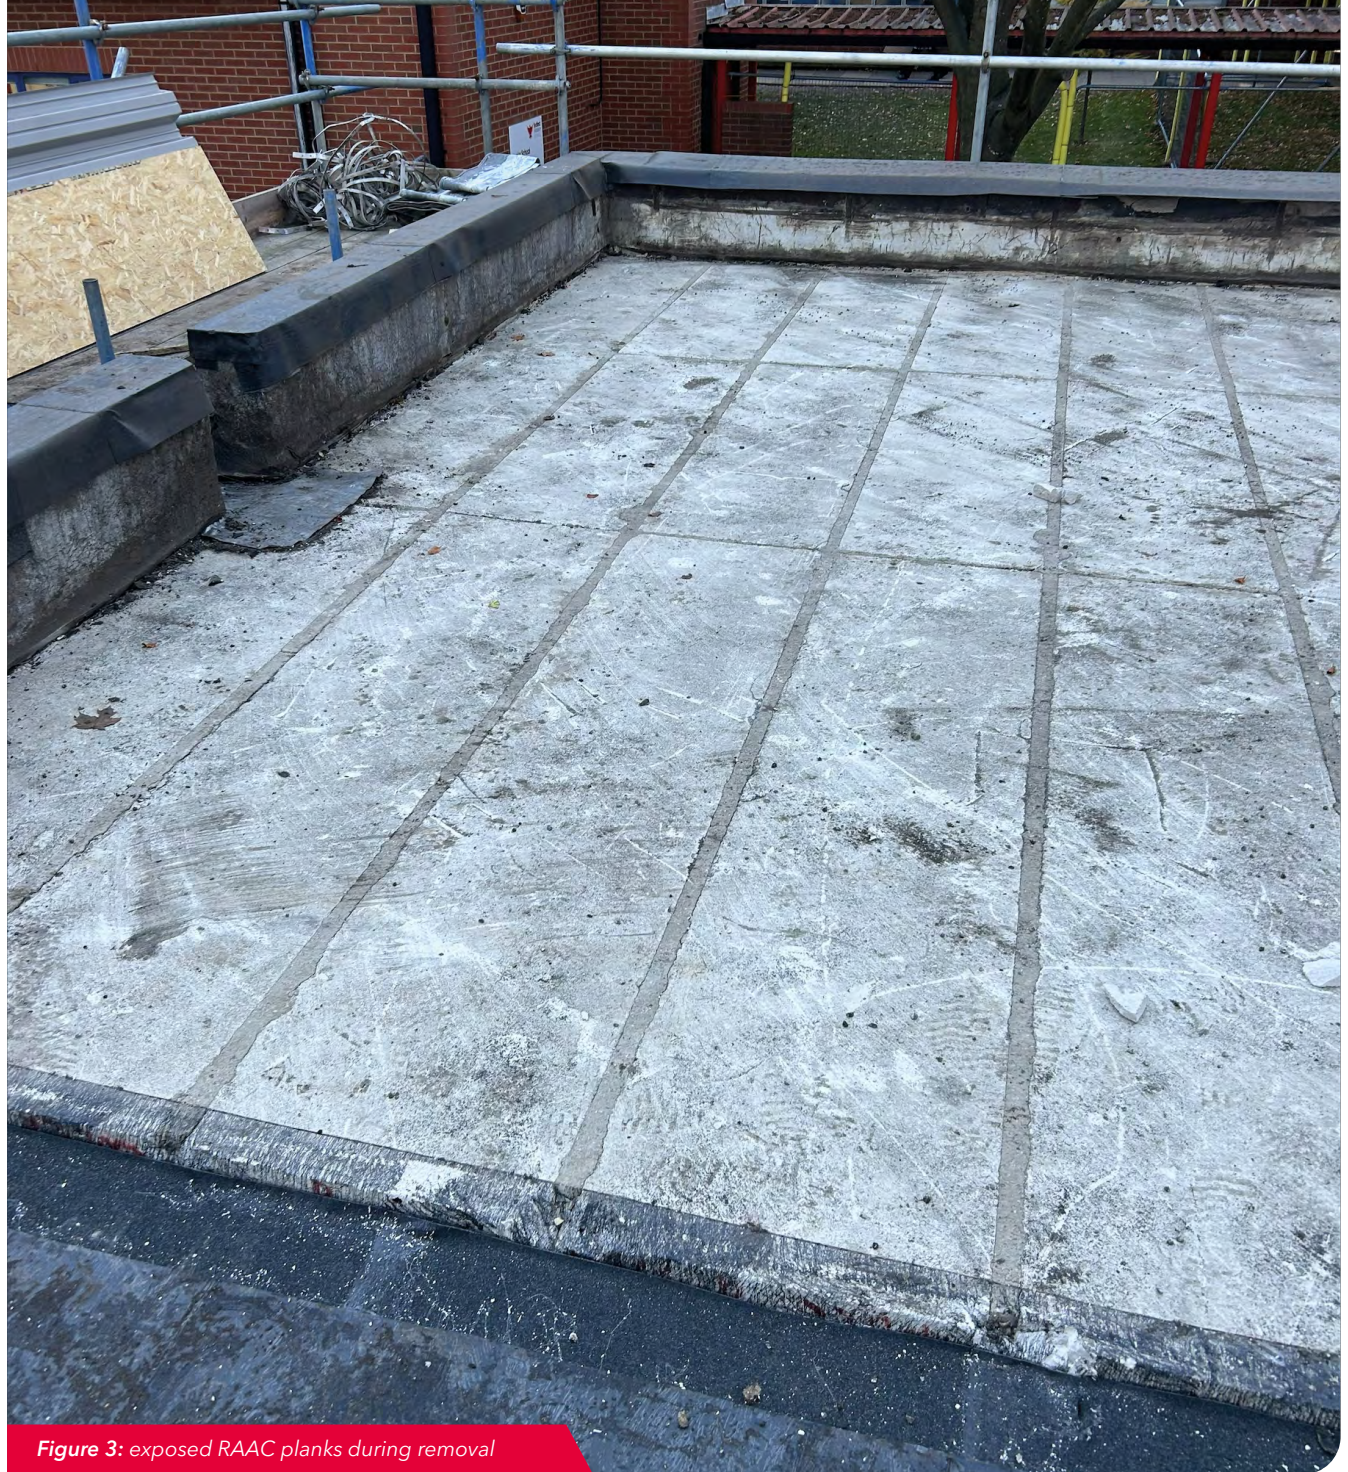
**Figure 3** shows the RAAC planks exposed once the existing waterproofing had been removed. The planks interlock so they had to be separated before they could be lifted out of position. Work was undertaken using appropriate personnel protective clothing and correct handling techniques. Soft-landing systems were installed in the classroom below to provide passive, collective fall arrest for their operatives removing the planks.

**Figure 3:** exposed RAAC planks during removal

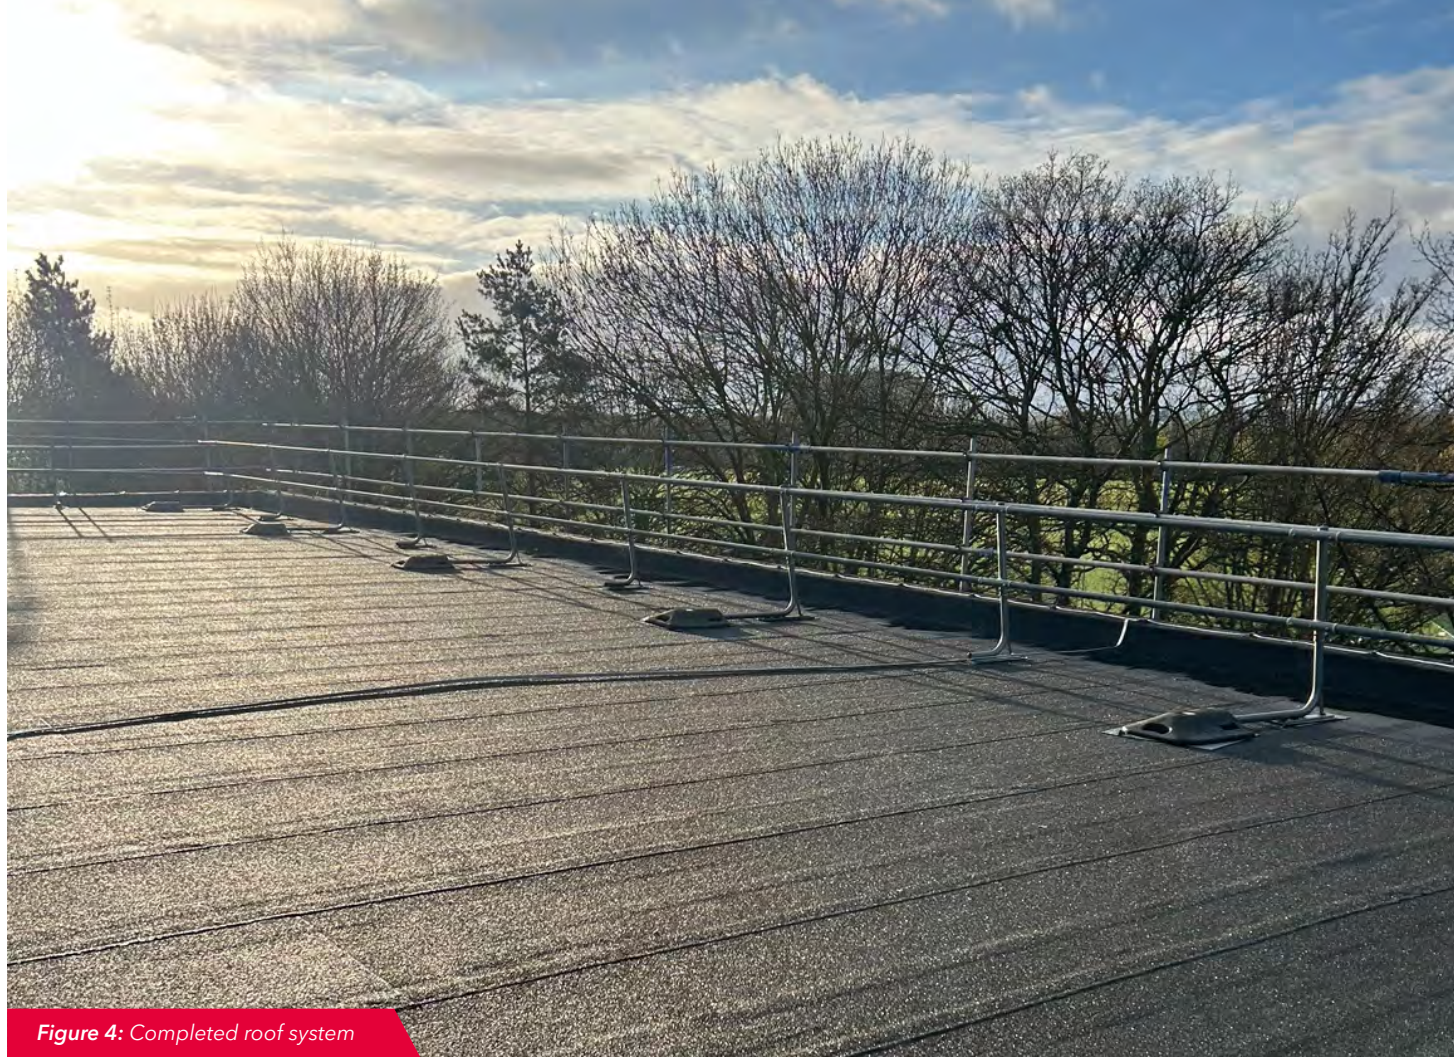
Figure 4: Completed roof system

M&J Group worked closely with the roof system supplier to develop a new roofing specification that would provide the school with a 30-year warranty. This comprised of a new 60 mm steel roof deck to the Junior School, and a 100 mm perforated acoustic deck on the sport halls. A fully self-adhesive Reinforced Bituminous Membrane (**RBM**) warm roof system, consisting of a self-adhesive Air and Vapour Control Layer (AVCL), tapered insulation scheme (*achieving the required of thermal performance as set out in Part L2 of the building regulations*) was then installed complete with a self-adhesive RBM underlay and mineral finish capsheet.

The RBM roof system was installed completely flame-free, without the use of propane gas torches, thus alleviating the fire risk, and allowing the school to function as normal. M&J Group have led the way in removing the need for naked flames when installing RBM systems—investing heavily in new tooling and equipment, including upskilling their work teams in flame-free installation techniques at their training facility.
