# NFRC Health & Safety Guidance (HSGS34)

## Protection of holes and voids on flat roofs

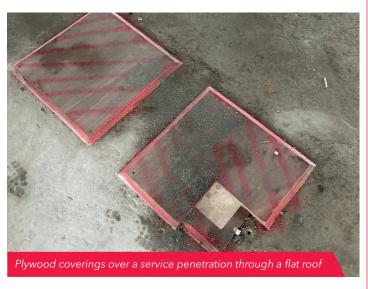
The following requirements should also be observed when plywood is used to temporarily cover a hole or void:

- The plywood must be in good condition and carefully checked to ensure it is structurally sound and with no damage or delamination.
- The grade and thickness of plywood should be ascertained by a competent person with the correct level of skills, knowledge, and experience.

- Any framework required to support the temporary plywood cover should be designed by a competent person with the correct skills, knowledge, and experience.
- Any fixings required to attach the plywood cover, or any supporting structure that may be needed, should be designed by a competent person with the correct level of skills, knowledge, and experience.
- The plywood should be clearly identifiable as a hole cover with signage and must not present a trip hazard.

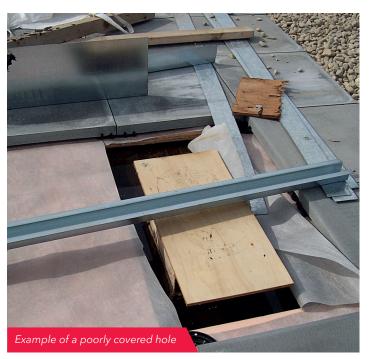
Plywood coverings can be damaged or become delaminated due to weathering–fixings loosen or warning paints fade and as such a regular inspection of all hole and void covers should be undertaken by the main contractor in line with their temporary works procedure. The roofing contractor should ensure that any hole or void protection covers that have been installed within their work area have a visual inspection before any works take place and if any concerns are noted these must be recorded with the main contractor to ensure that any remedial works required are undertaken.
